UNIVERSITY OF ALBERTA
ENVIRONMENT, HEALTH & SAFETY

Containment Level 3 Sanitary Drain Line Incident November 15, 2018

CL-3 Sanitary Drain Line Incident

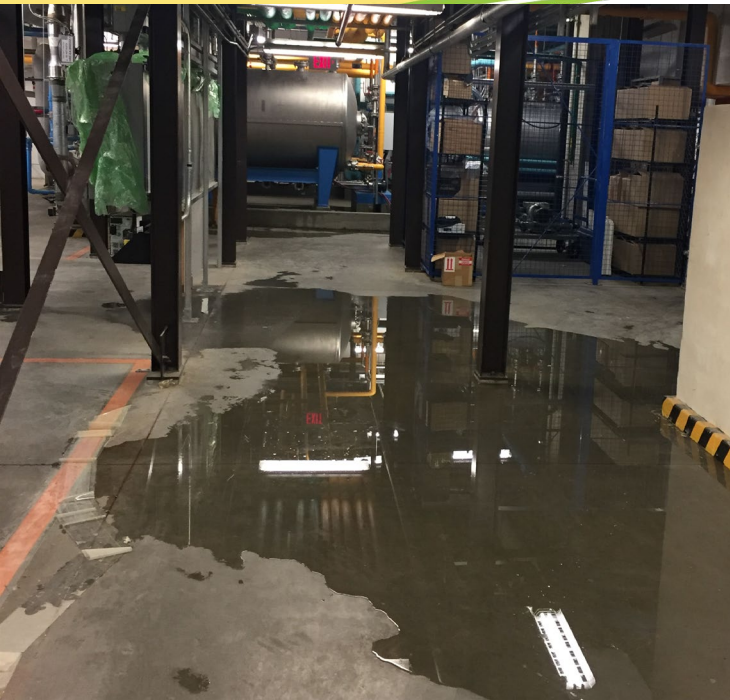
November 15th . . . within the infrastructure support area for the CL3

1 F&O Millwrights discover water on floor and pouring from the ceiling

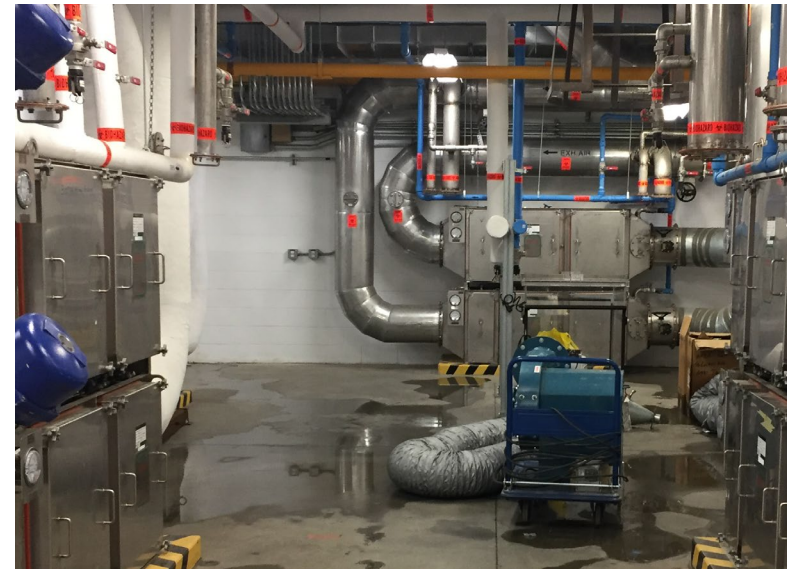
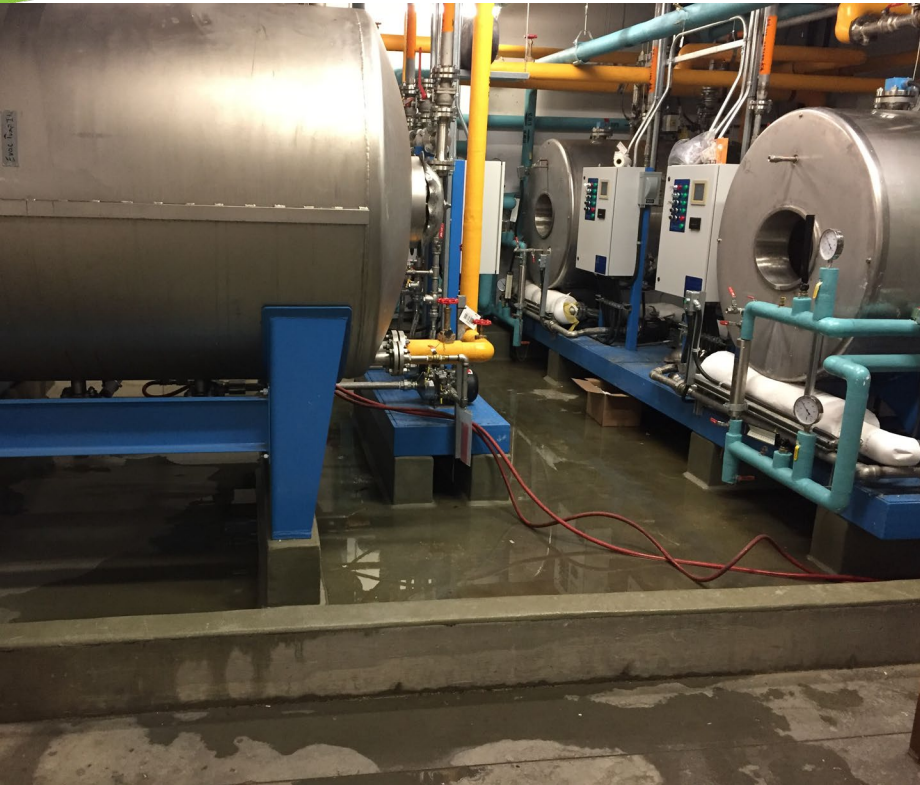
2 Water leaked on equipment, ventilation systems, electrical control panels

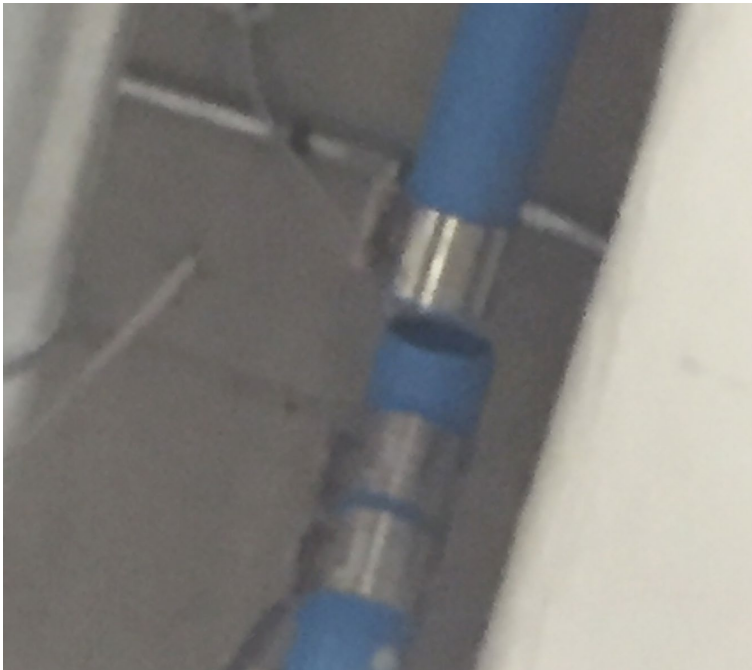
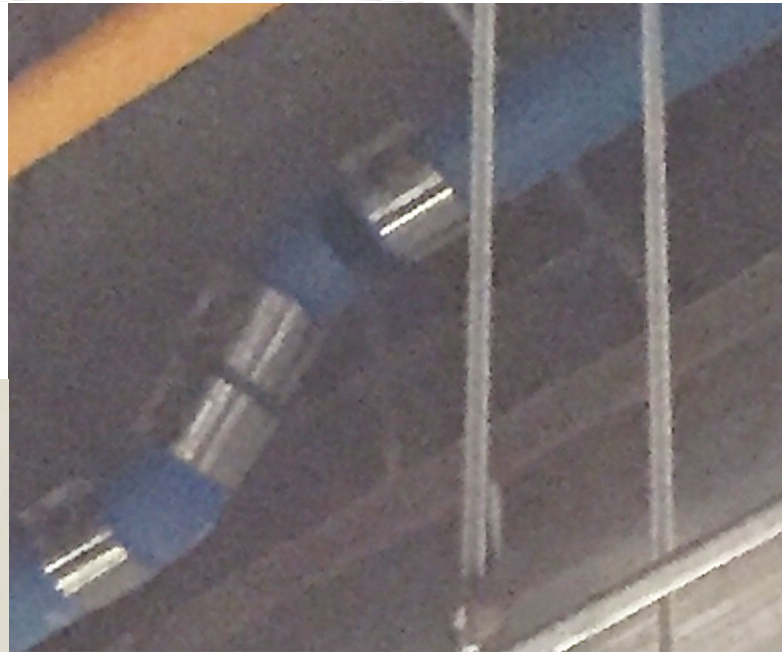
-
-
- 3** Hydroclave holding tanks found FULL with water backing up through the drainage system

Weight of water caused the several joints on the drain line to fail; some lines broke

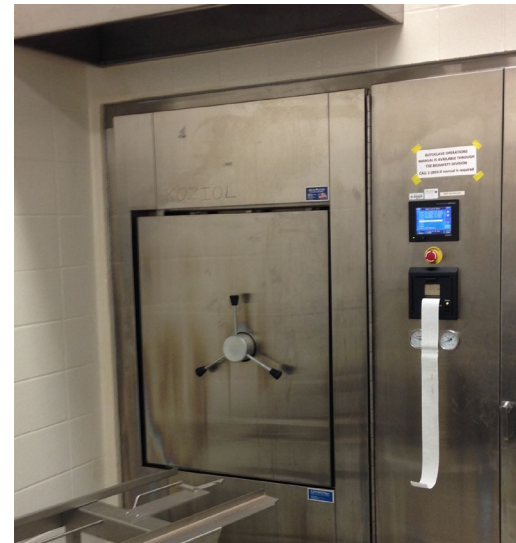
CL3 Autoclave identified as source of the water

Air valve controlling the cooling water valve FAILED on one autoclave

- very rare type of failure
- water valve forced open
- domestic cold water running continuously at building pressure

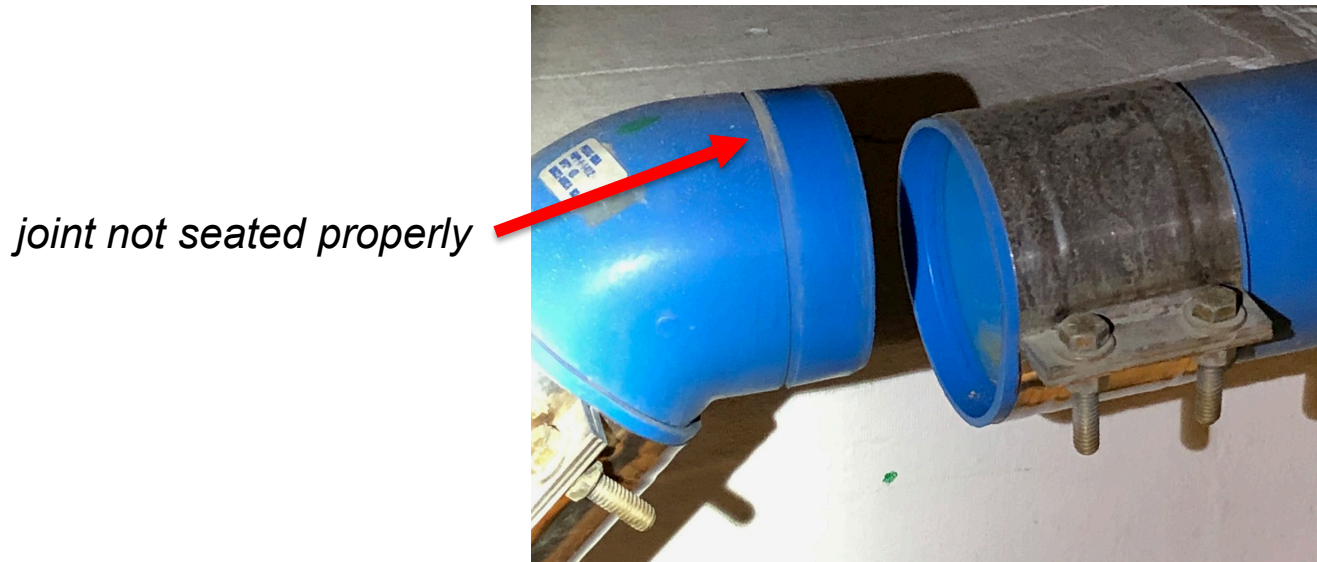
- Integrity of drainage system – improper installation, inadequate supports

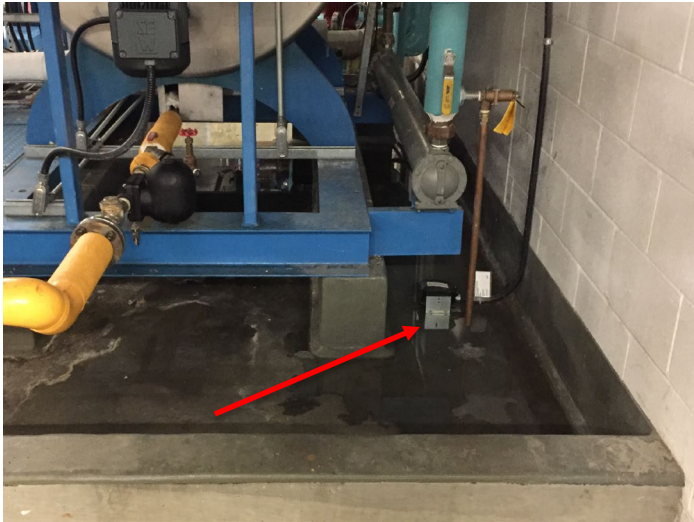
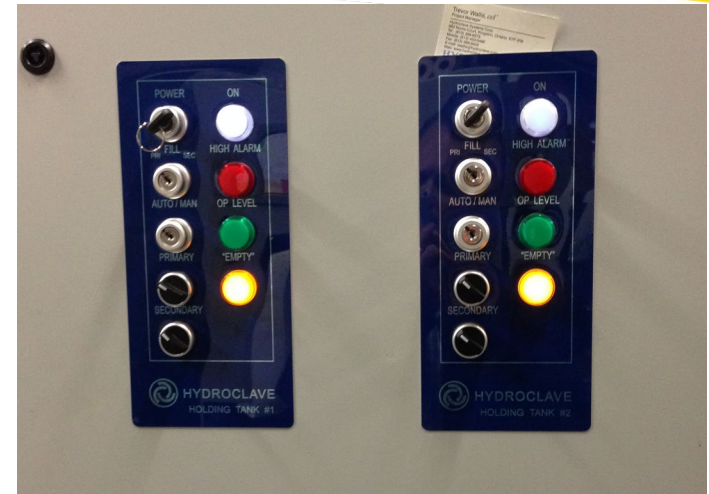
- Hydroclave system was offline with high level alarms inoperative for impending maintenance

- Moisture sensor position ineffective
