# **VIDO-InterVac – Case study of epoxy coating remediation within a working CL3-Ag facility**

Cam Ewart; Associate Director –  
Operations & Maintenance

Vaccine & Infectious Disease Organization -  
International Vaccine Centre (VIDO-InterVac)  
University of Saskatchewan

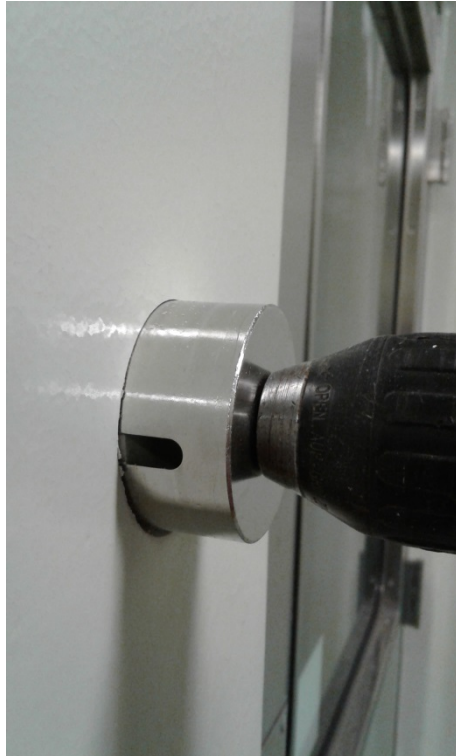
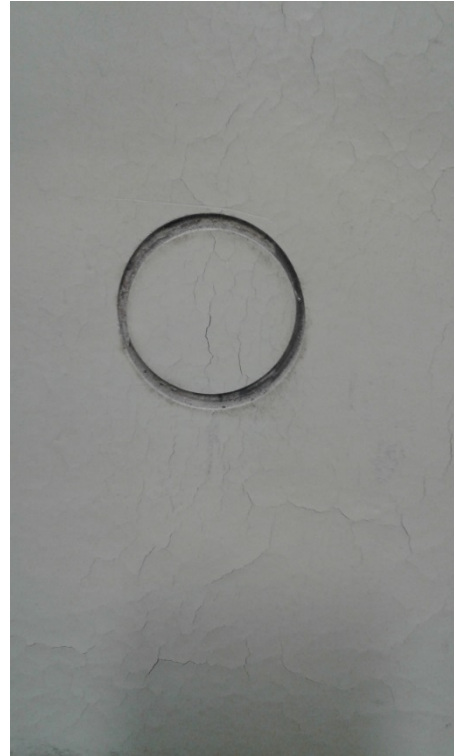
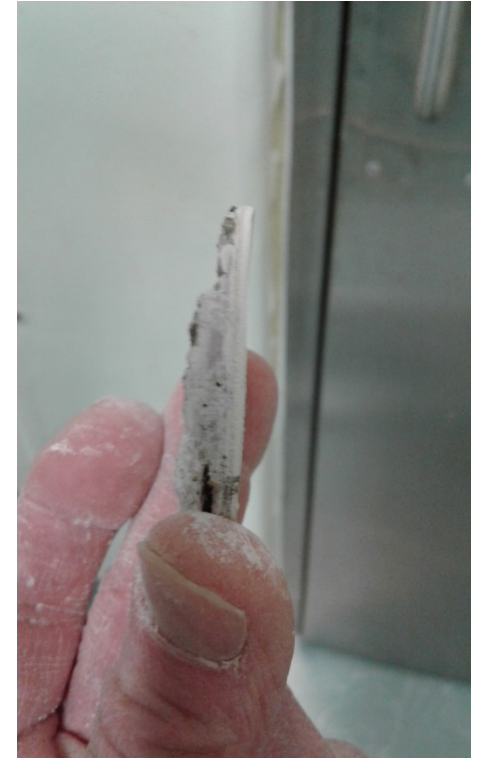
# Epoxy coating replacement – analysis

- Core samples taken from areas of epoxy failure
- 10 samples taken from differing types of appearance
- Sent to suppliers US lab for structural & chemical analysis.....

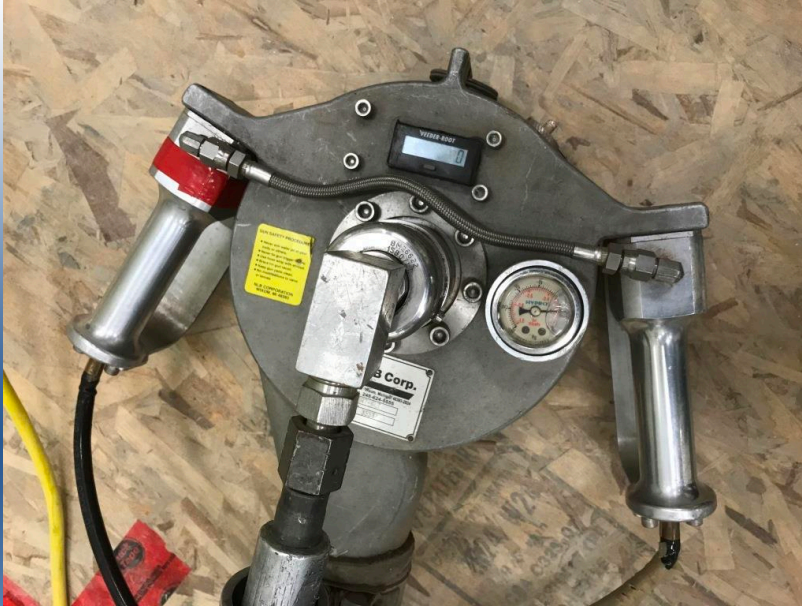
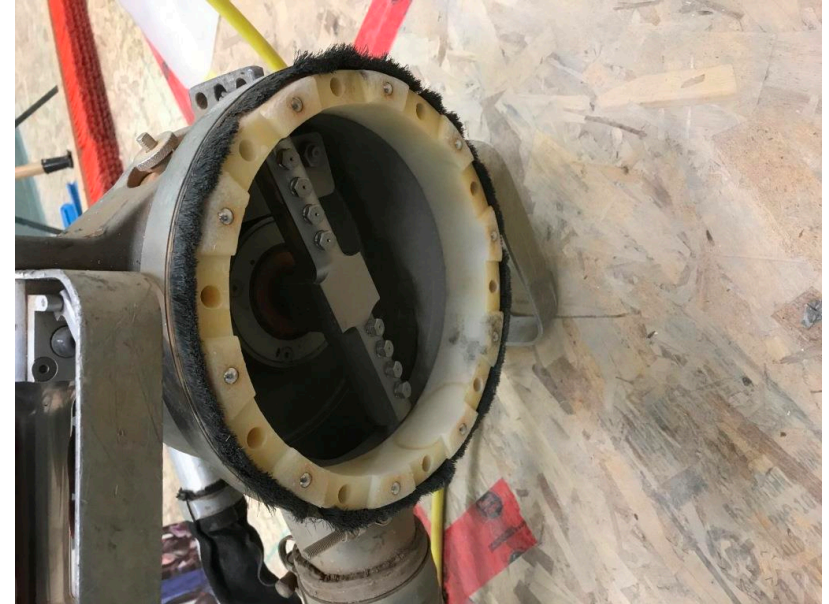
# Epoxy coating replacement – epoxy removal

- Waterjetting removal of epoxy
- water shoots out of underside of application head at 40, 000 PSI
- pulverized epoxy slurry vacuumed up by head
- supply of water and collection of slurry controlled by equipment housed in seacans placed at the west loading dock

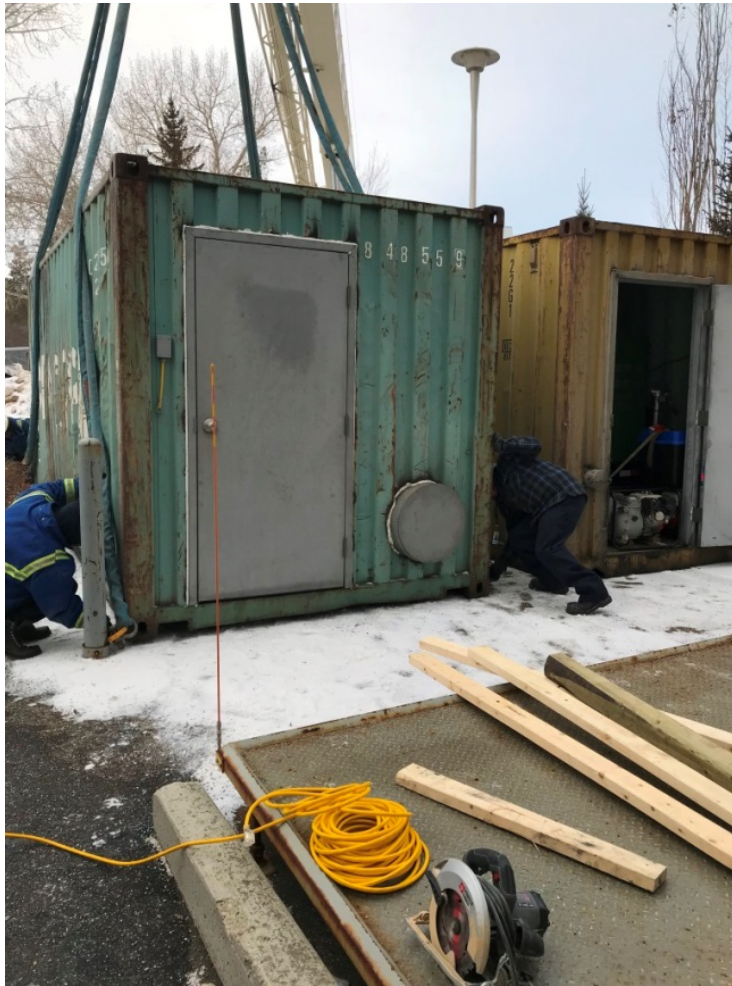
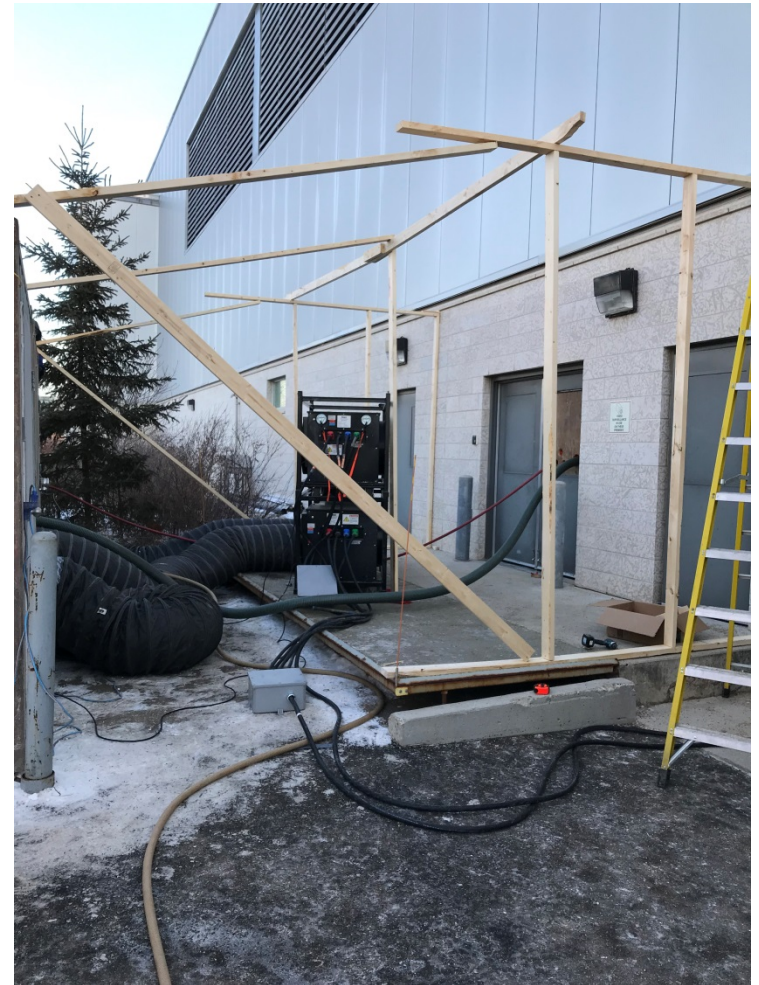
# Epoxy coating replacement - execution

- Seacans about 20 feet from west loading door
- heated hording to keep lines from freezing

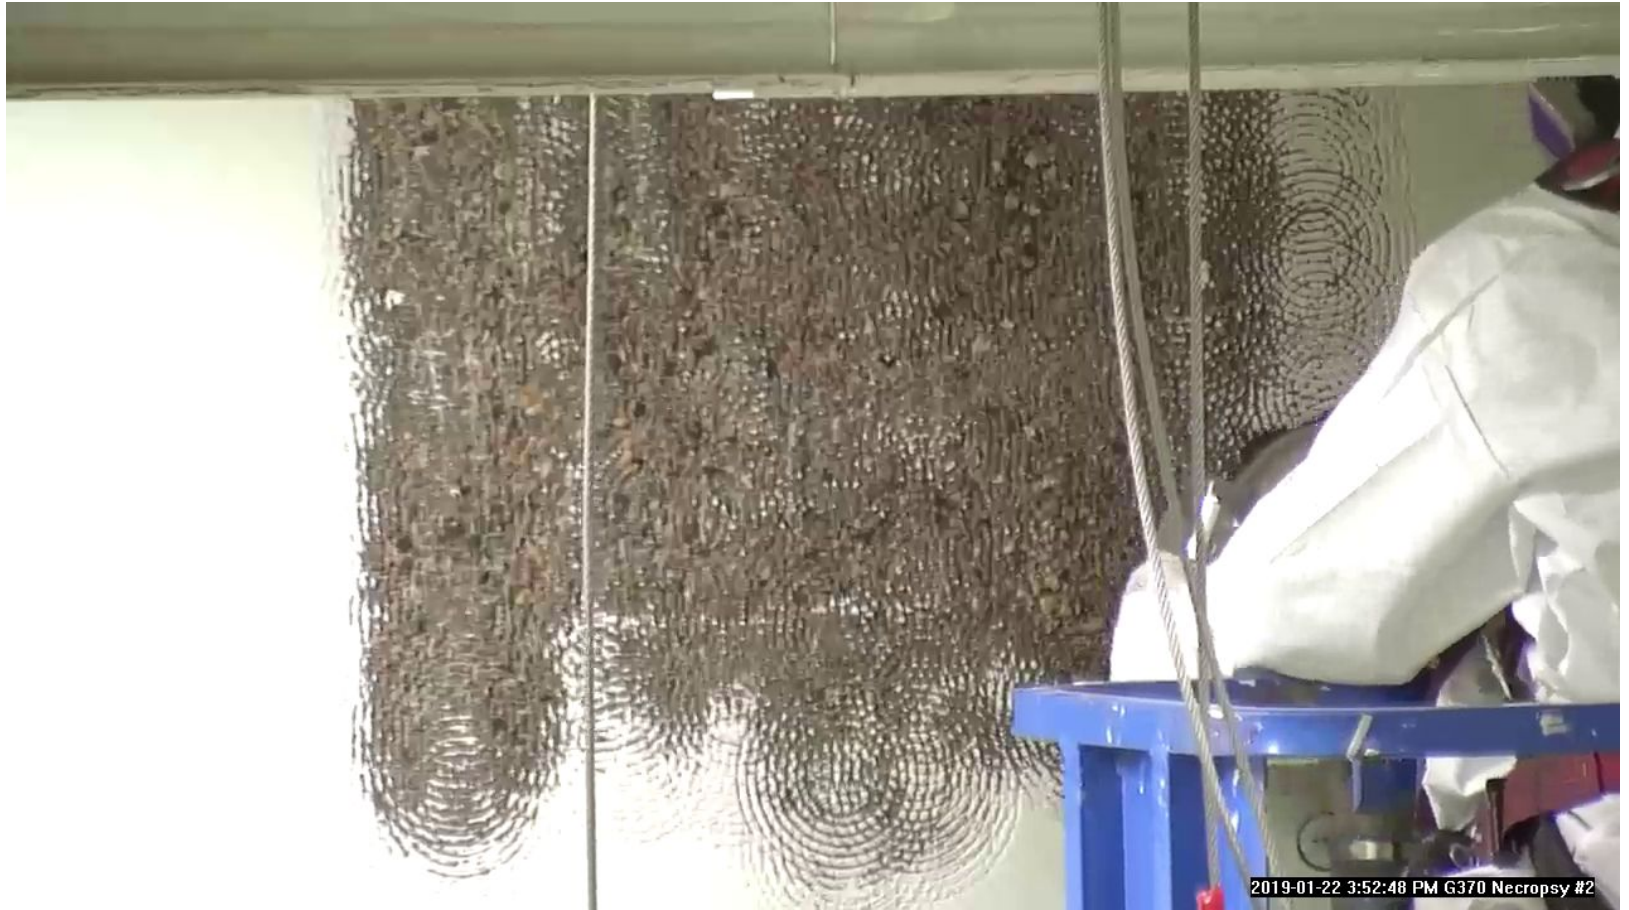
View from ceiling CCTV camera in Necropsy – first section of epoxy removal  
Going well - this shouldn't be that difficult.....

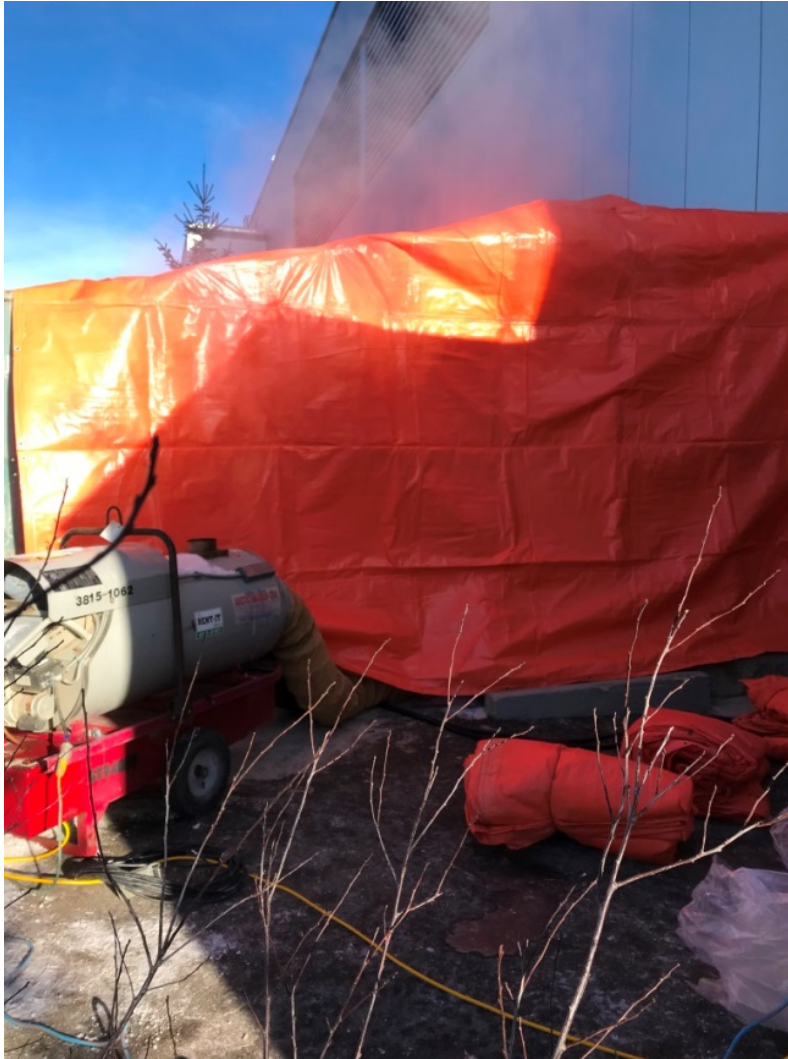
# Epoxy coating replacement – epoxy removal

- Polar vortex began in late January
- Daily highs were 10-15 degrees below average  
nightly lows
- record low temperatures for weeks
- February was the cold month in history

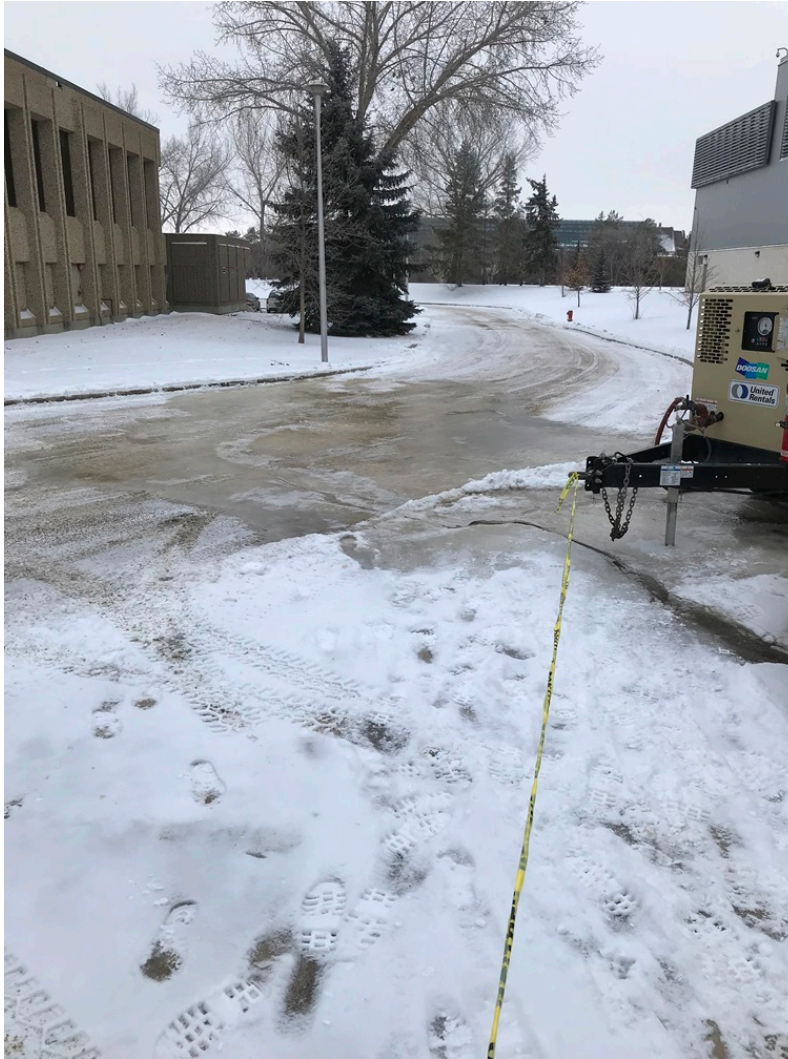
# Epoxy coating replacement – epoxy removal

- Polar vortex began in January
- Daily highs were 10 degrees below average nightly lows
- record low temperatures for weeks
- February was the cold month in history
- February 08....-43 at 9:00 am; -54 with wind chill
- Residual water leaking from seacans and flooding neighboring facility access road

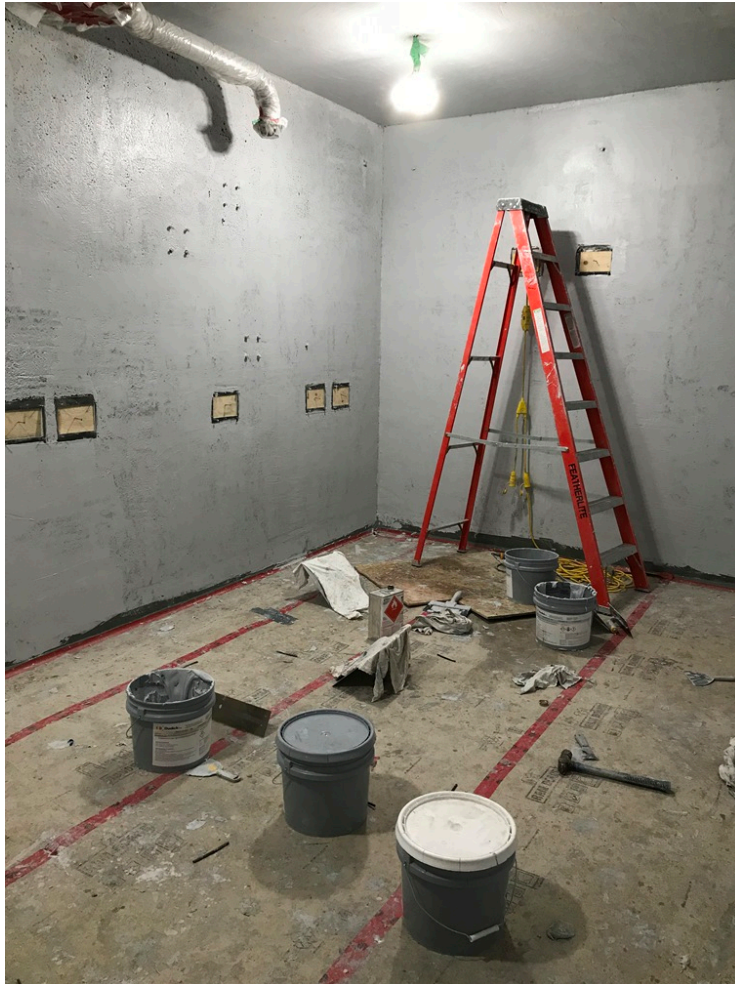
Sealant and 1<sup>st</sup> layer of filler

- Steri-Seal HB built-up barrier coating
  - concrete sealer
  - Primer 67
  - 2 layers of Scratch-coat
  - 2 layers of two part epoxy finish
  - 1 layer of UV topcoat 30
- Supplier had to provide 3<sup>rd</sup> party testing and validation for product resistance to commonly used decontamination products (VHP, Formaldehyde, Cavacide, Virkon, Microchem, etc)
- Direct application oversight by Dudick site representative
- Site reviews by Architecture 49 (original site rep)

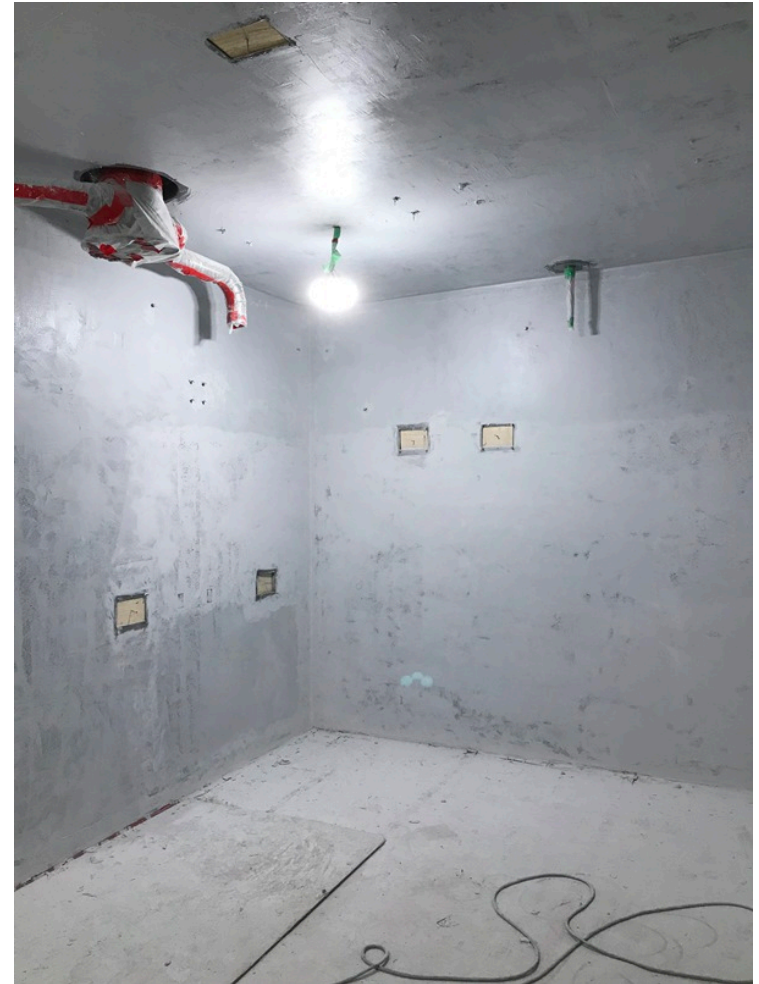
2<sup>nd</sup> later of filler (grind between each layer with grinders)

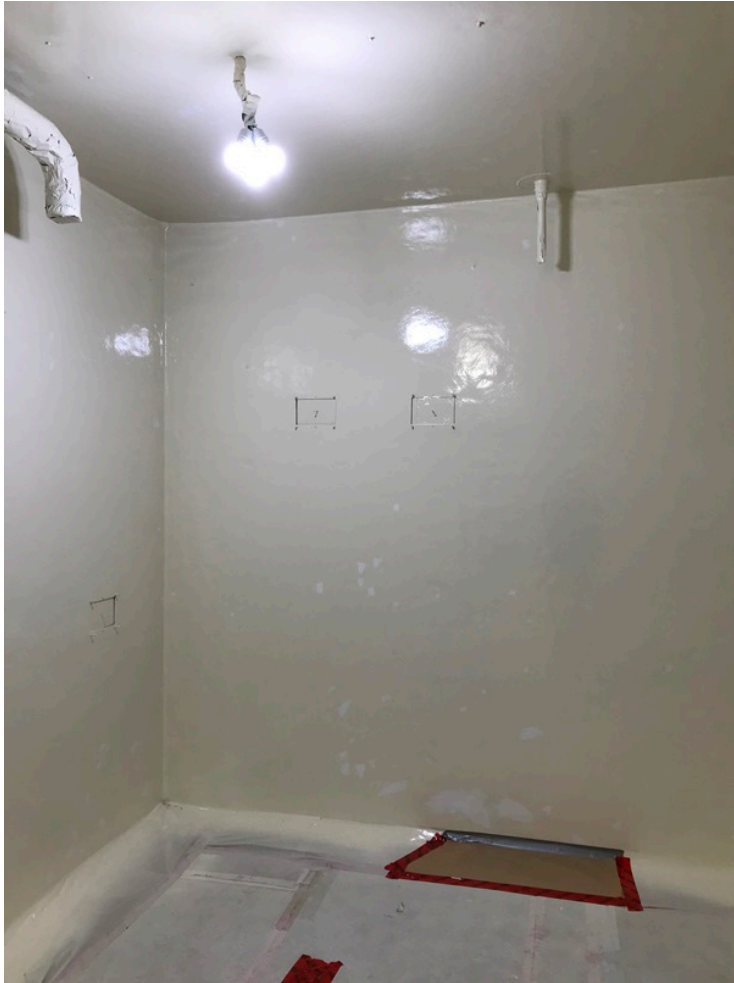
1<sup>st</sup> layer of 2 part epoxy

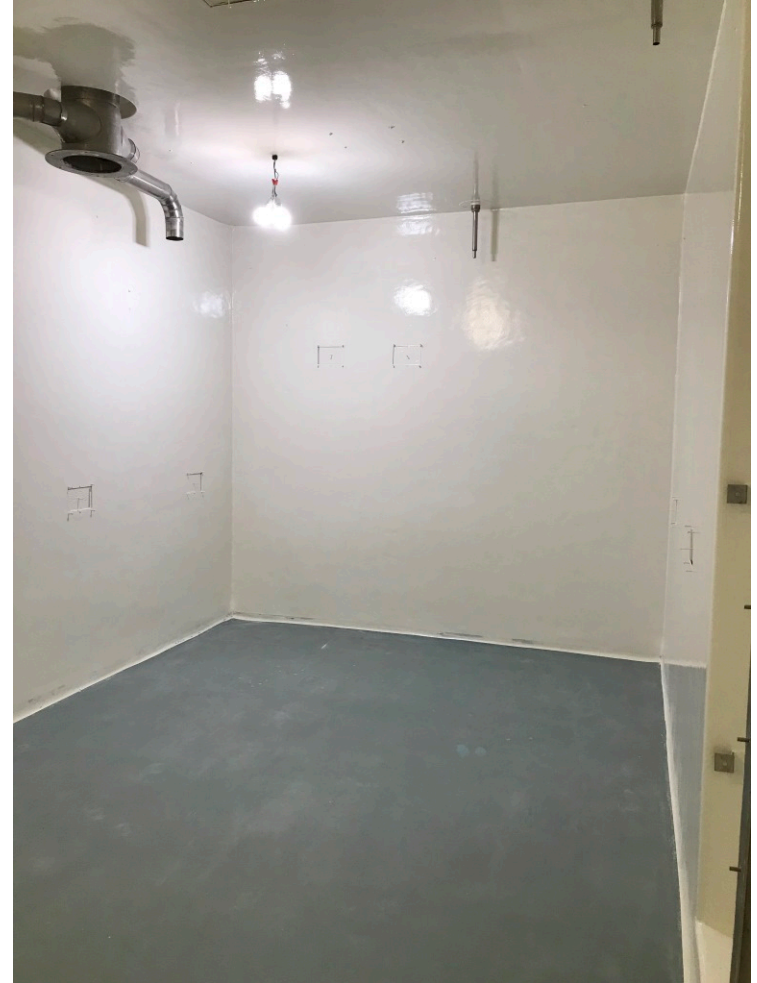
2<sup>nd</sup> layer of 2 part epoxy (sand and fully clean between applications)

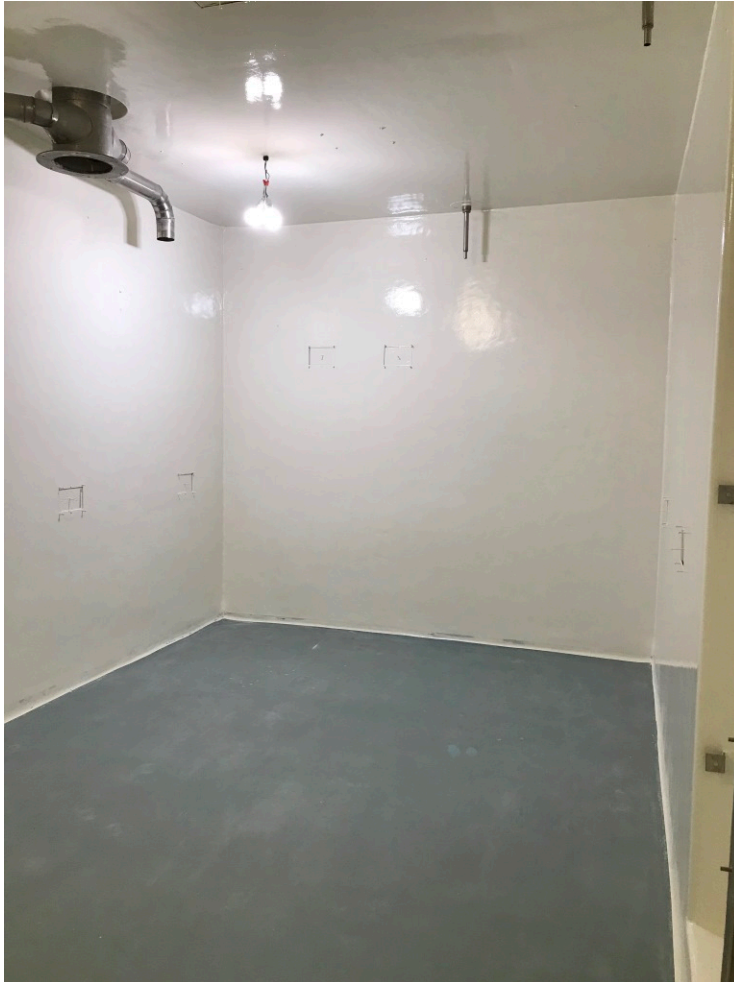
UV resistant clear topcoat

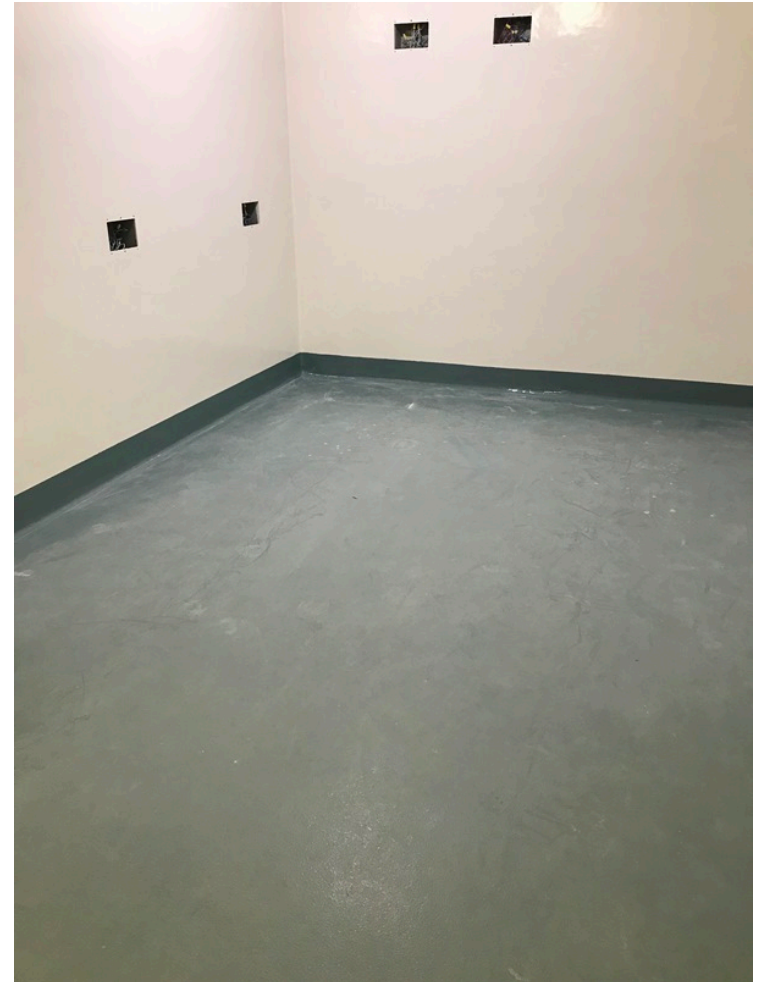
Reinstallation of covered baseboard assembly

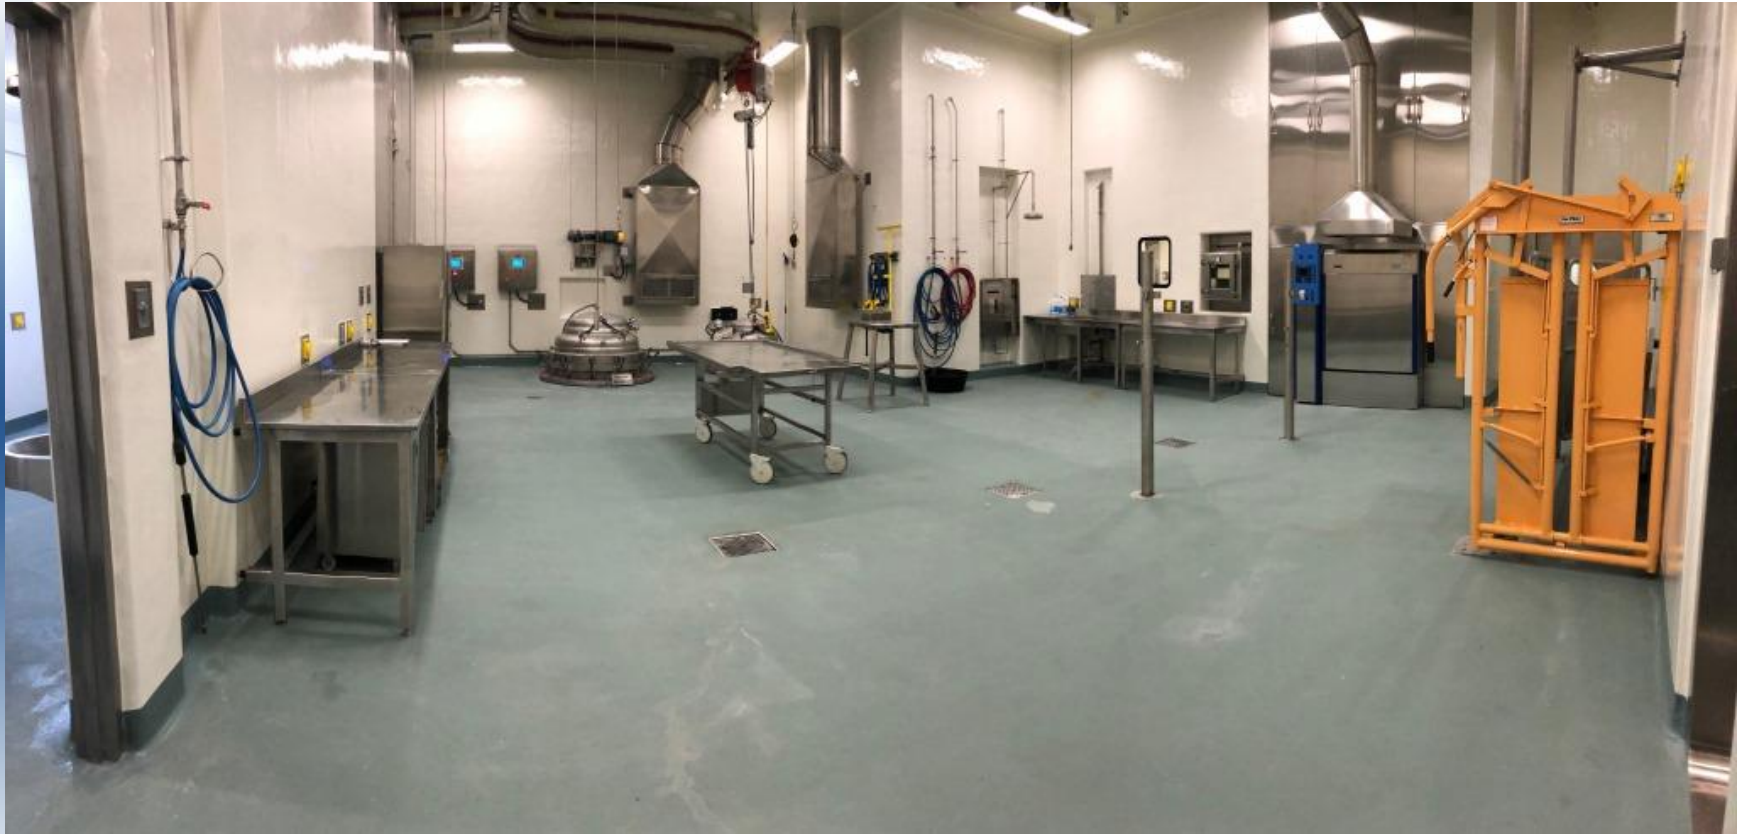
Necropsy laboratory complete – April 26, 2019
