Cycle Development of Vaporized Hydrogen Peroxide (VHP) Under Room Exhaust Conditions in the CL3 Laboratory

Joanna Spinato Public Health Ontario Laboratories (PHOL) - Toronto September 18, 2019

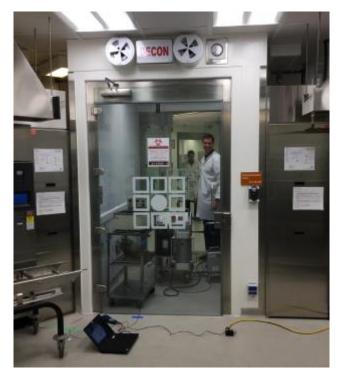
A 350ft³ decon room on the perimeter of the CL3 equipped with a trim valve

- Trim valve allows small amount of
 VHP to exhaust
 - inward directional airflow maintained
 - VHP leak into adjacent space prevented
- PHOL strives to evolve beyond current practice
 - establish decon method that may safety be run during business hours with minimal impact to CL3 operations

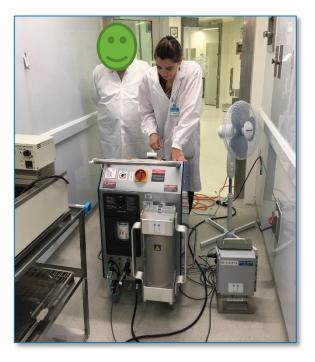
Steris VHP 1000ARD

- Port VHP generator to decon room
- Inlet/return ports in room mismatched to generator fittings
 - VHP generator using 35% H₂O₂ installed inside decon room

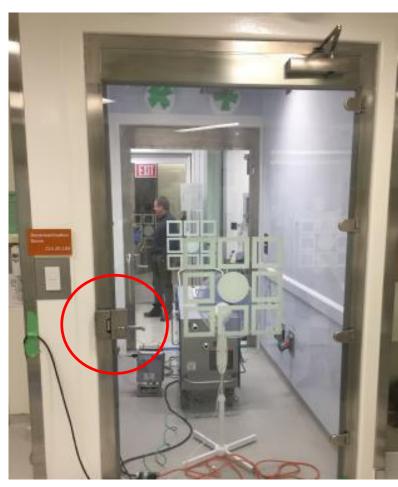
Run 1 – Results

- Cycle started normally
- Significant leakage at CL3 door latch
 @ 10 min into decon phase -> run
 was aborted
- CIs showed adequate colour change

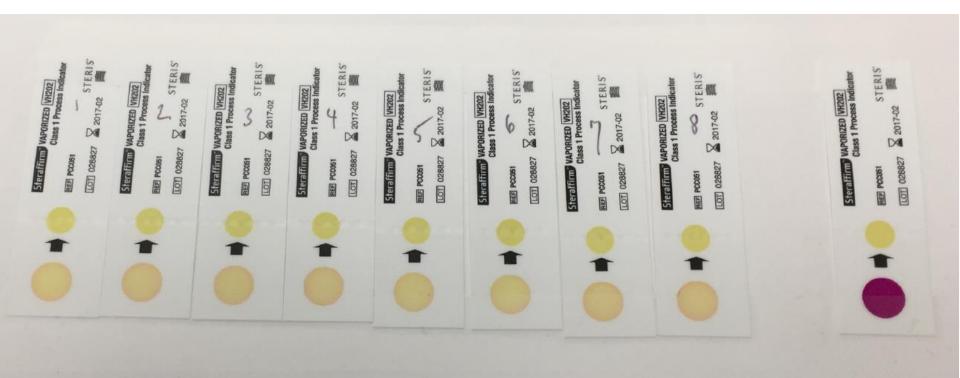
Chemical indicators (CI)

- Cycle proceeded w/o issue
- Decon phase-- Some condensation noted on CL3 door @ 10 min into phase, subsided throughout rest of run
- Aeration phase -- residual VHP = 1.2 ppm @ 2 hours in
- CIs well turned
- Bls collected, transferred to media vials, incubated at 55-60°C for 7 days
 - No BI showed growth at 7 days
